**DECLARATION OF KYLE LUTZ IN  
SUPPORT OF DEFENDANTS'  
MOTION TO DISMISS OR, IN THE  
ALTERNATIVE, MOTION FOR  
SUMMARY JUDGMENT**

## Travis Moreda Dairy List of Improvements

# Representative Photographs of Improvements

### CONFINED ANIMAL FACILITY COMPLIANCE INSPECTION

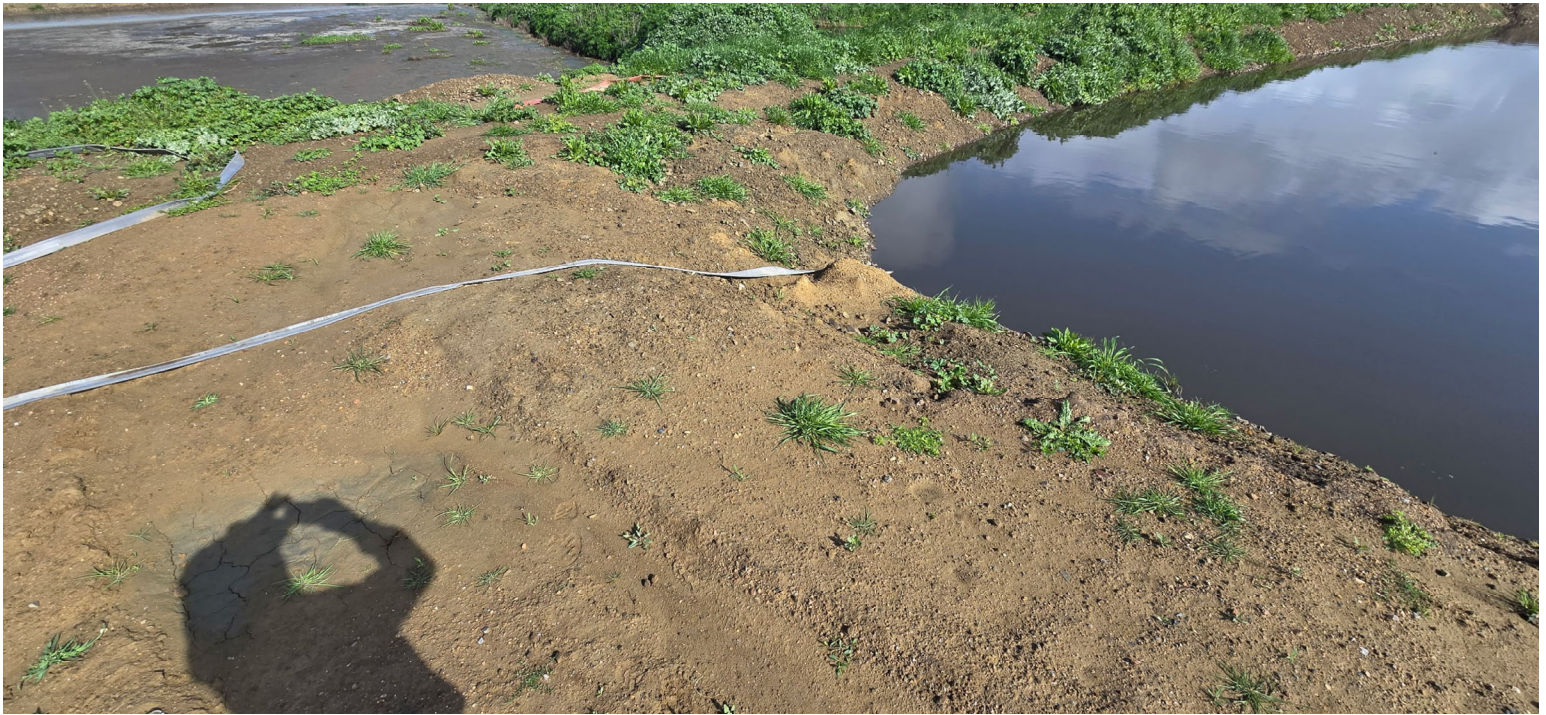
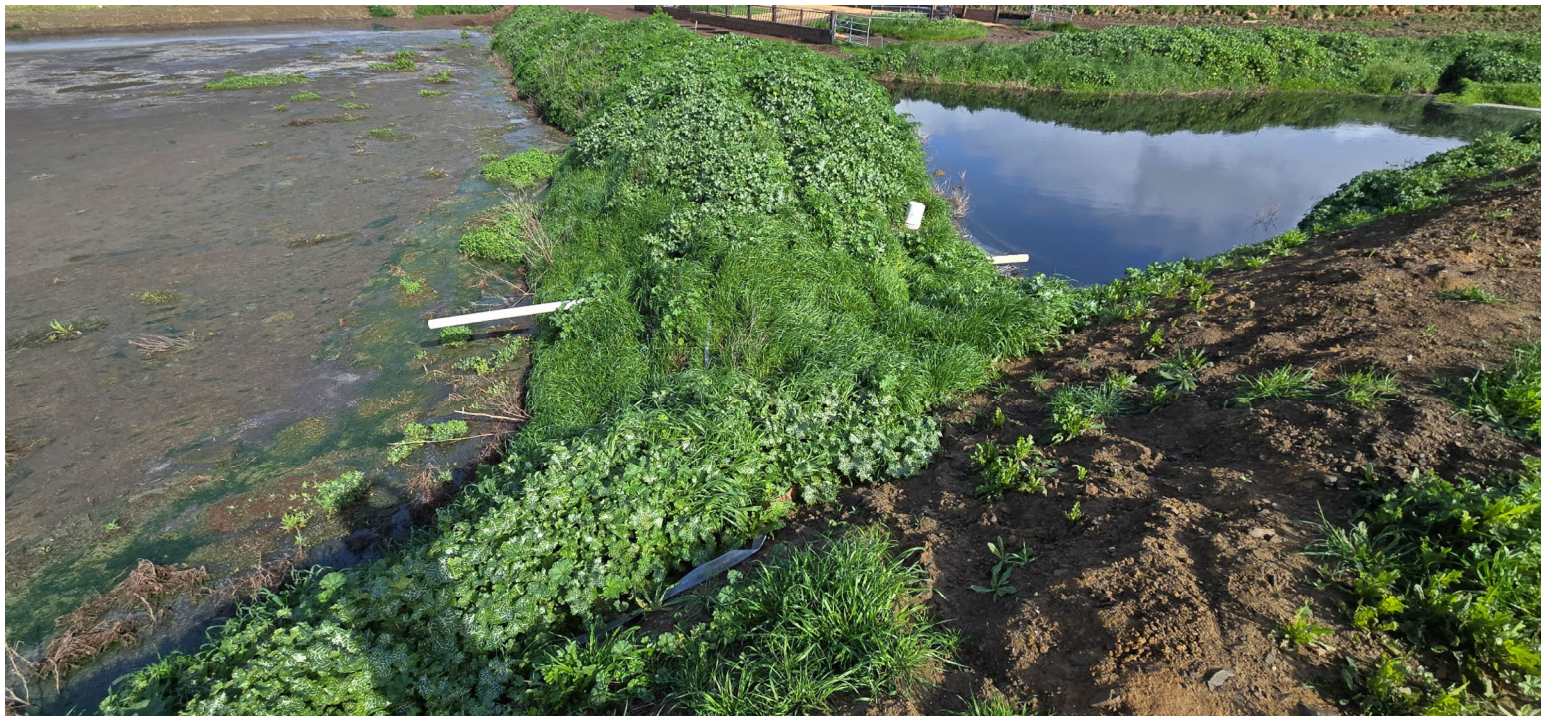
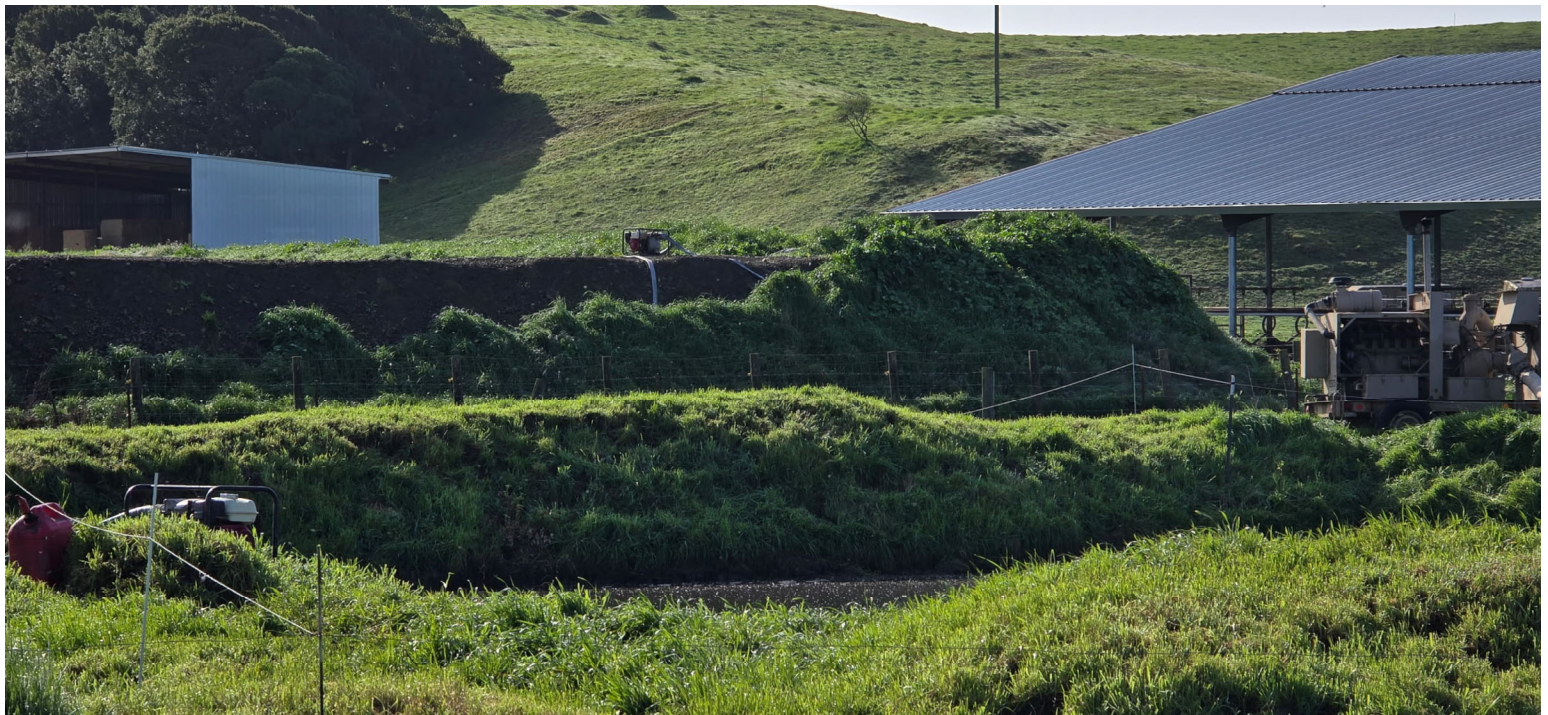
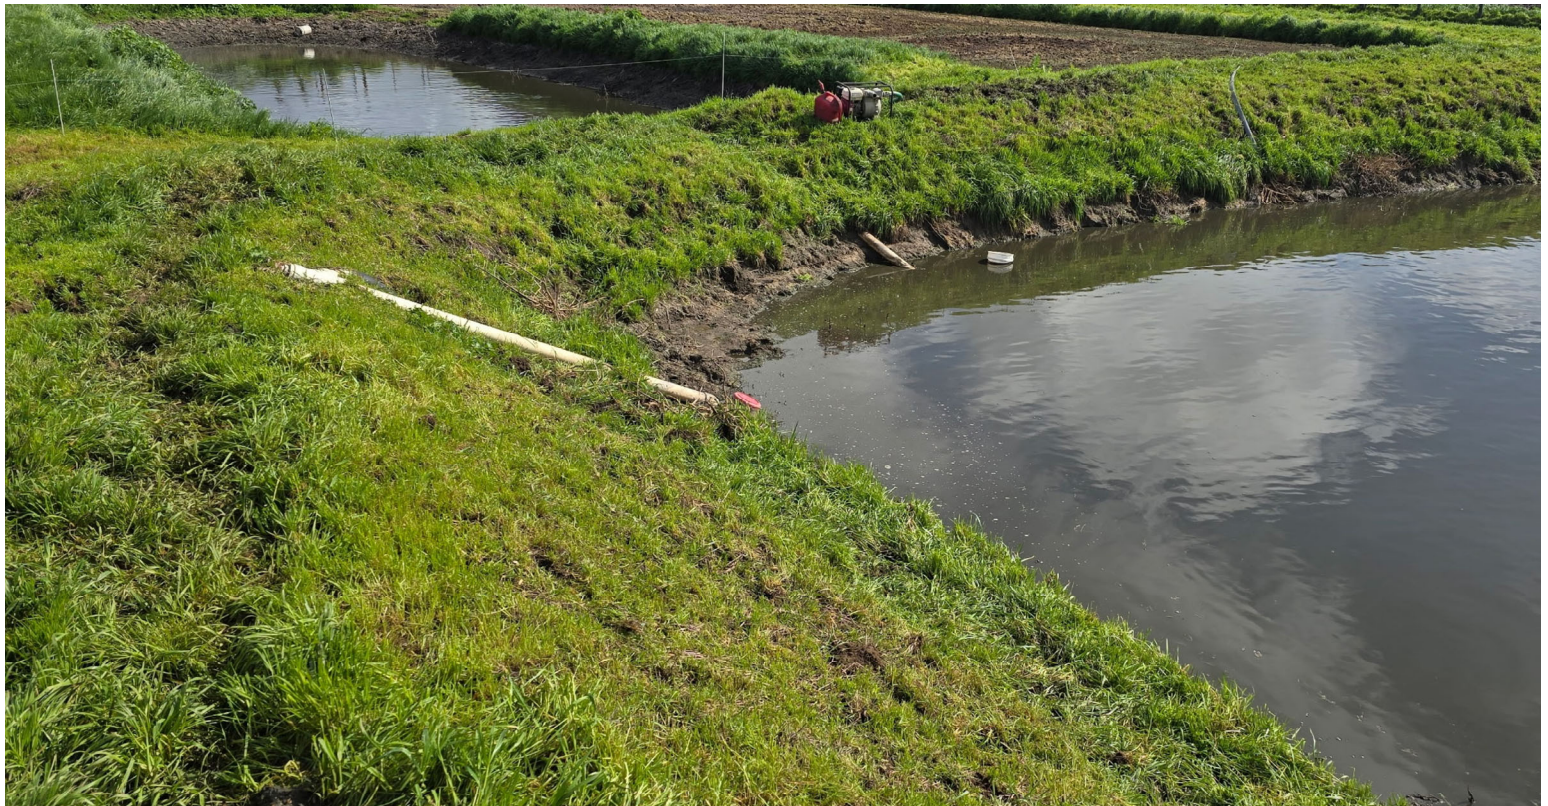
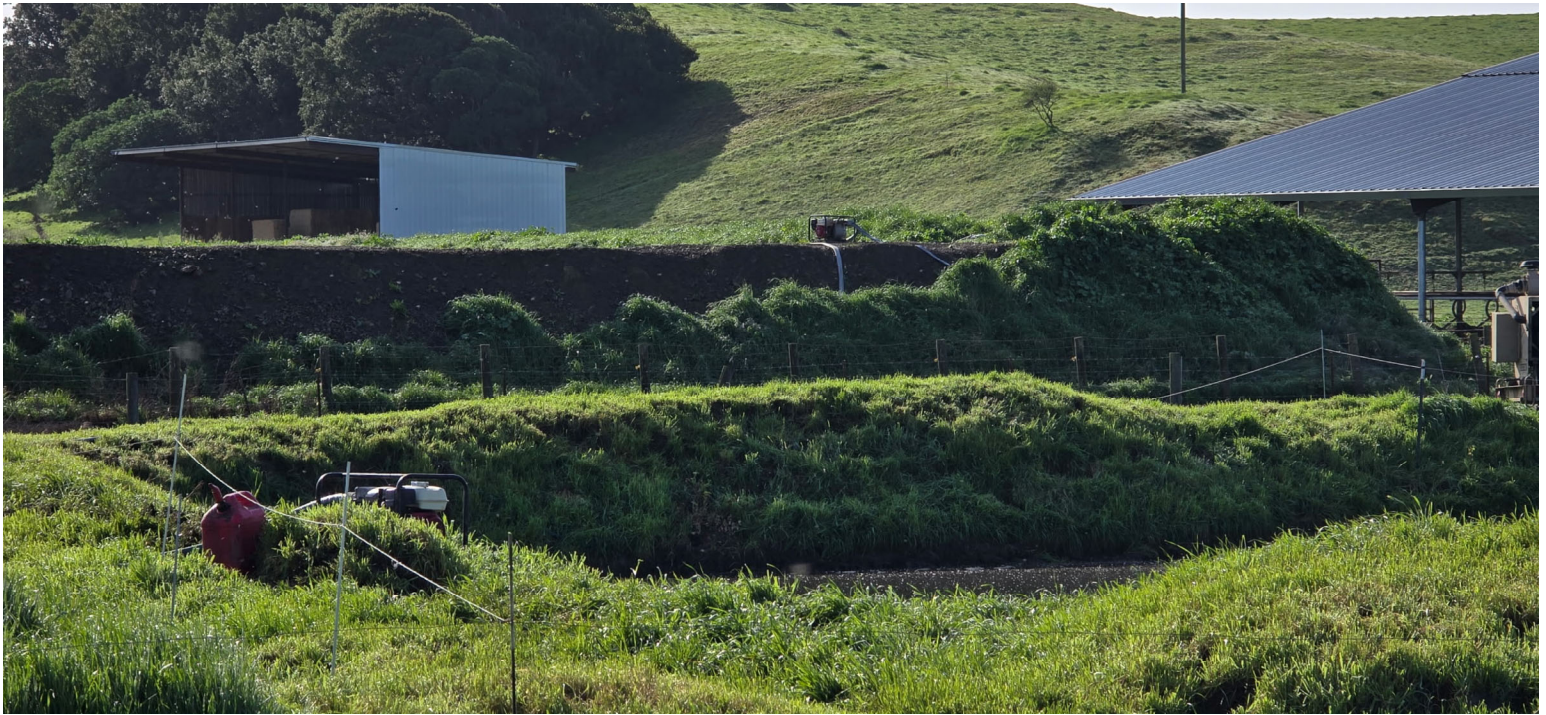
Conveyance system between lagoons

- 2.) Conveyance System/Lagoon Connection to Storage System: Prior to this improvement, not all of the existing manure lagoons were hydrologically connected. Previously, the dairy relied on one pump to ensure the successful transfer of wastewater between all five lagoons. Now, 5 additional pumps are available to create the ability to mechanically manage all of the wastewater lagoons as one unit. The pumps, in addition to overflow pipes between some of the ponds, allow for the convenient transfer of manure between ponds through the use of gravity and mechanical means. This allows for the sufficient combined capacity referenced in the Waste Management Plan.

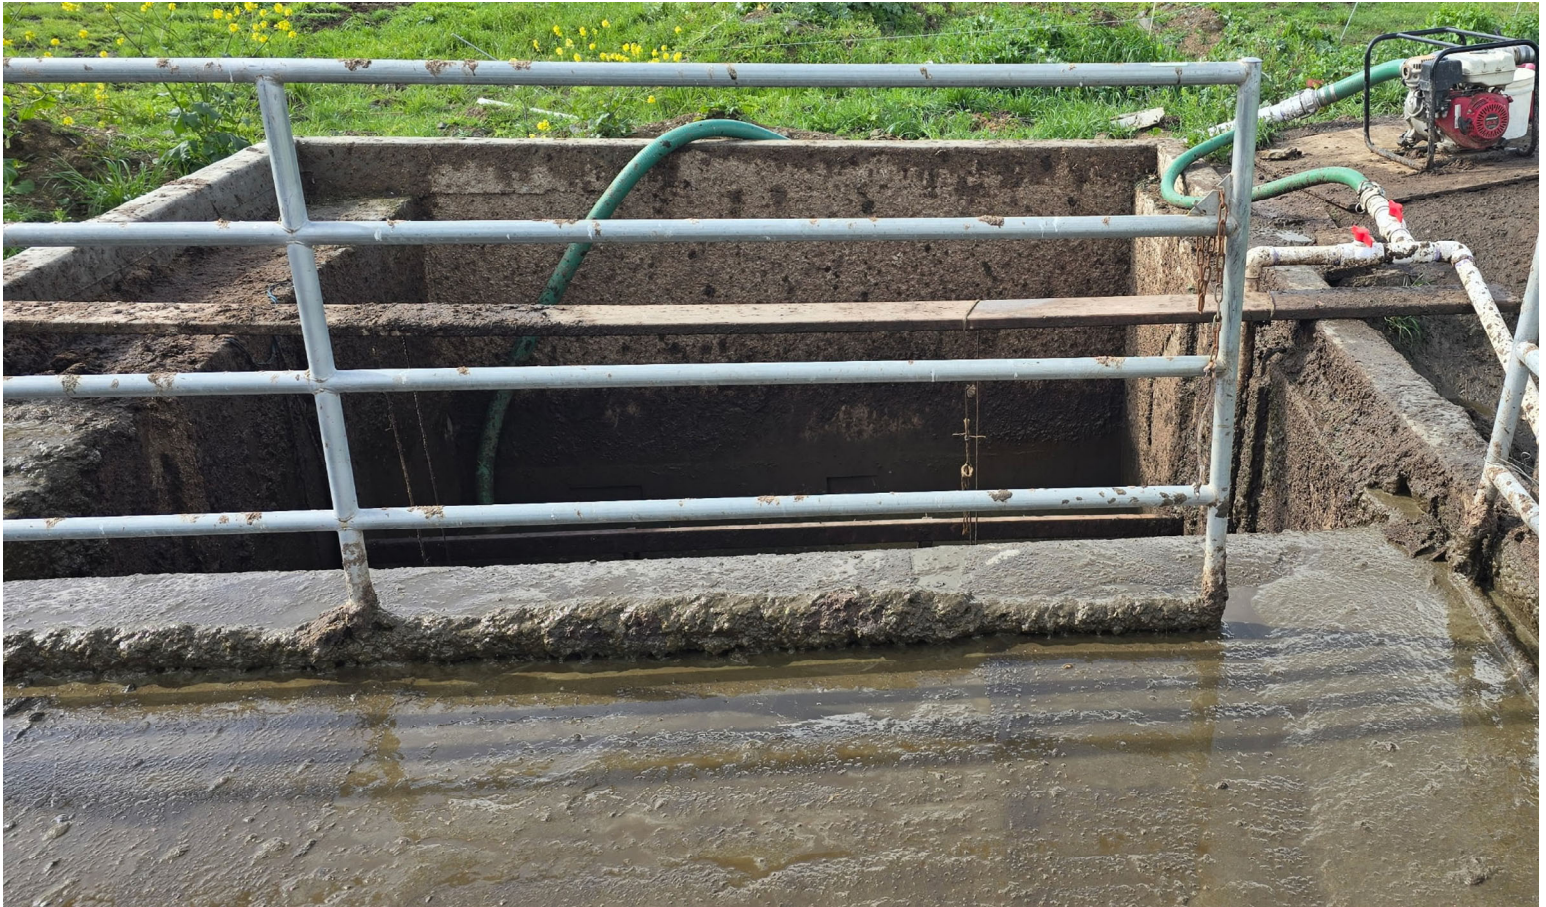
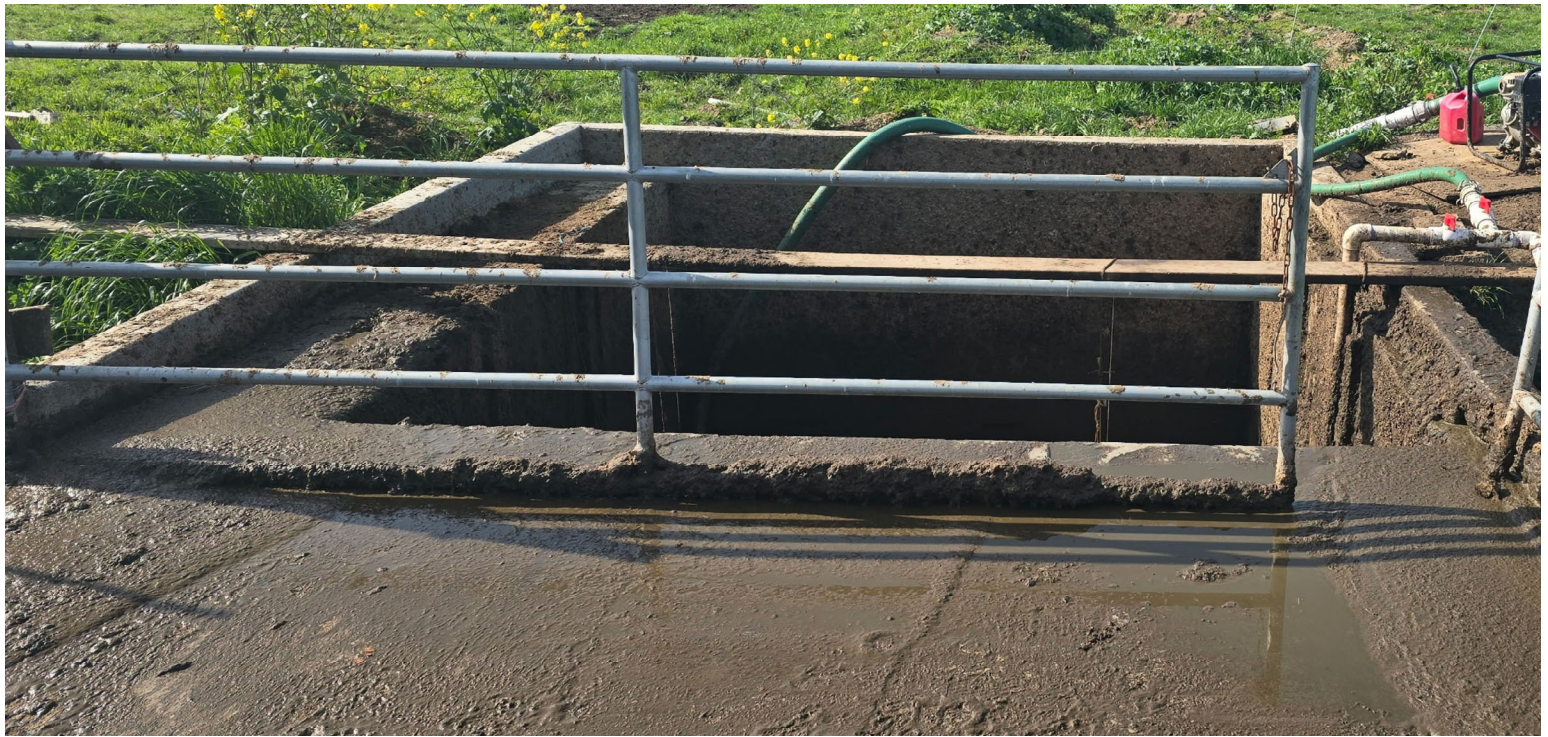
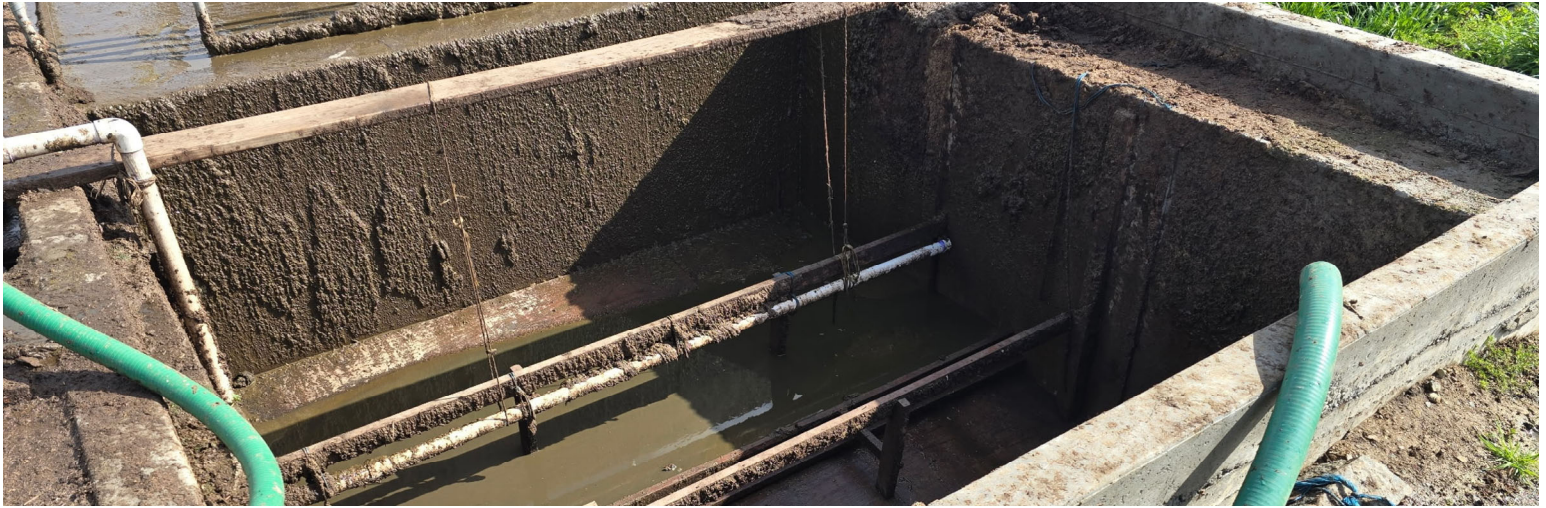
Concrete-lined reception pit below Free Stall Barn

- 1.) Free Stall Barn Manure Containment: Prior to this improvement, manure produced within the free stall barn was scraped into an area below the barn where it was contained with a dirt berm. A concrete-lined reception pit was constructed below the Free Stall Barn. This allows for manure produced within the Free Stall Barn and on the walkway at the front of the Free Stall Barn to be scraped into the reception pit. Manure and related wastewater that enters the reception pit is now pumped into the existing lagoon system. Back up pumps are available on site to ensure the successful transfer of manure should the present pump require repair.

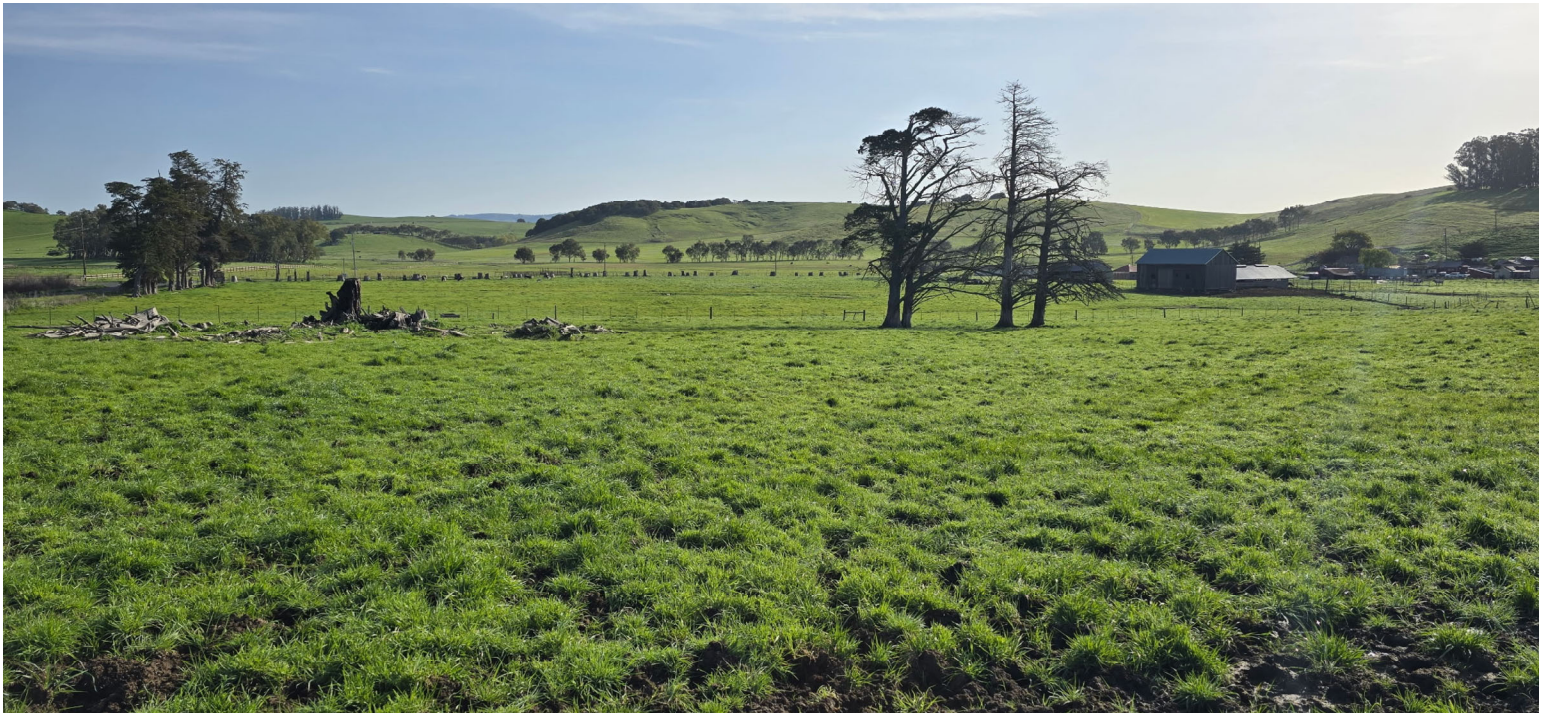
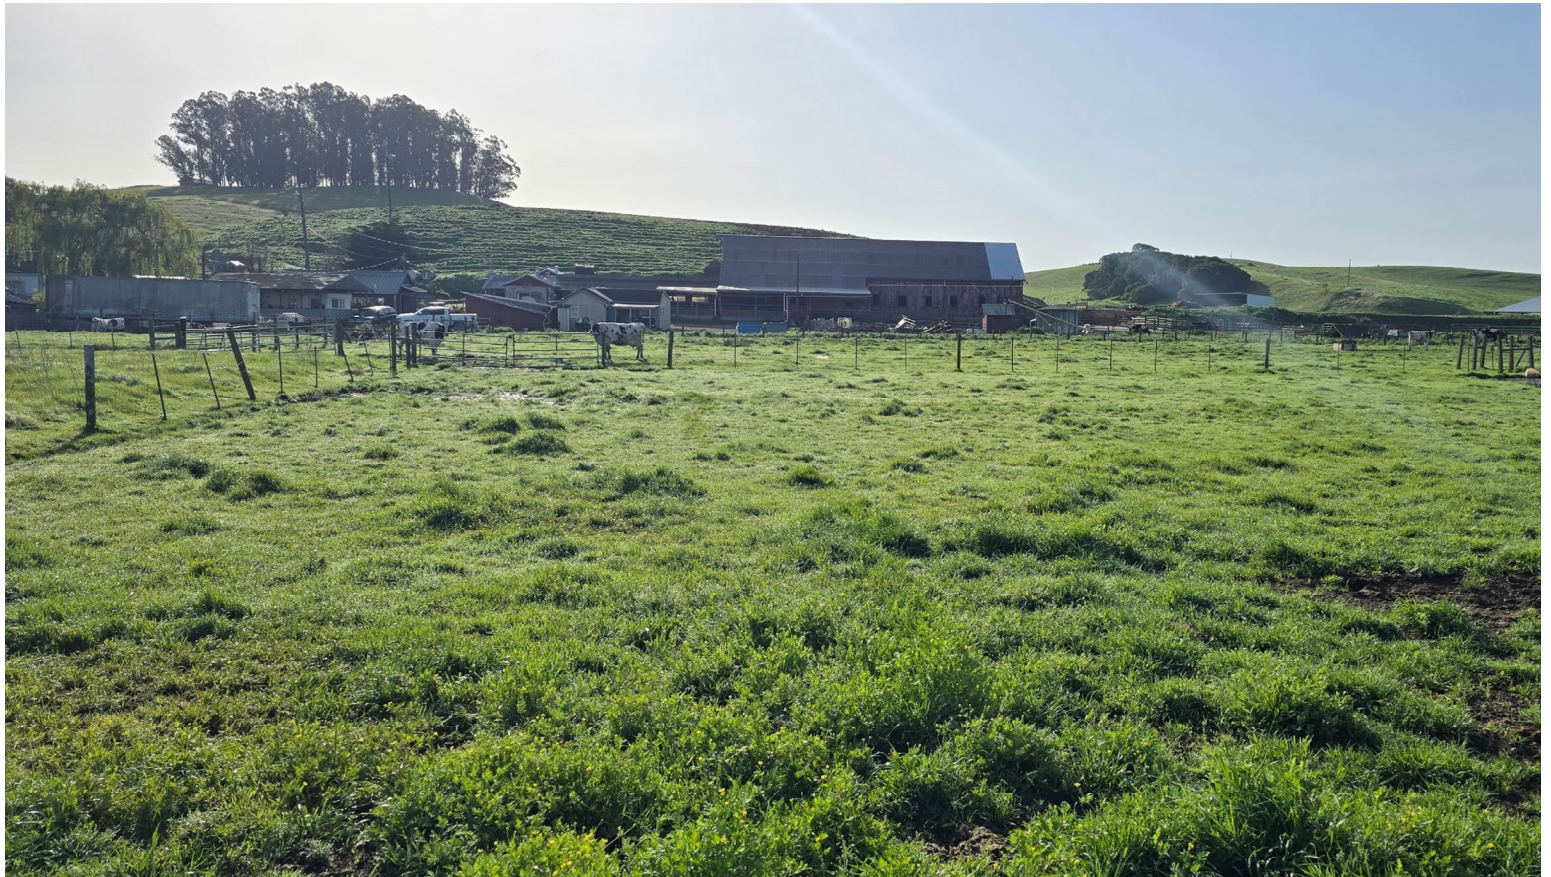
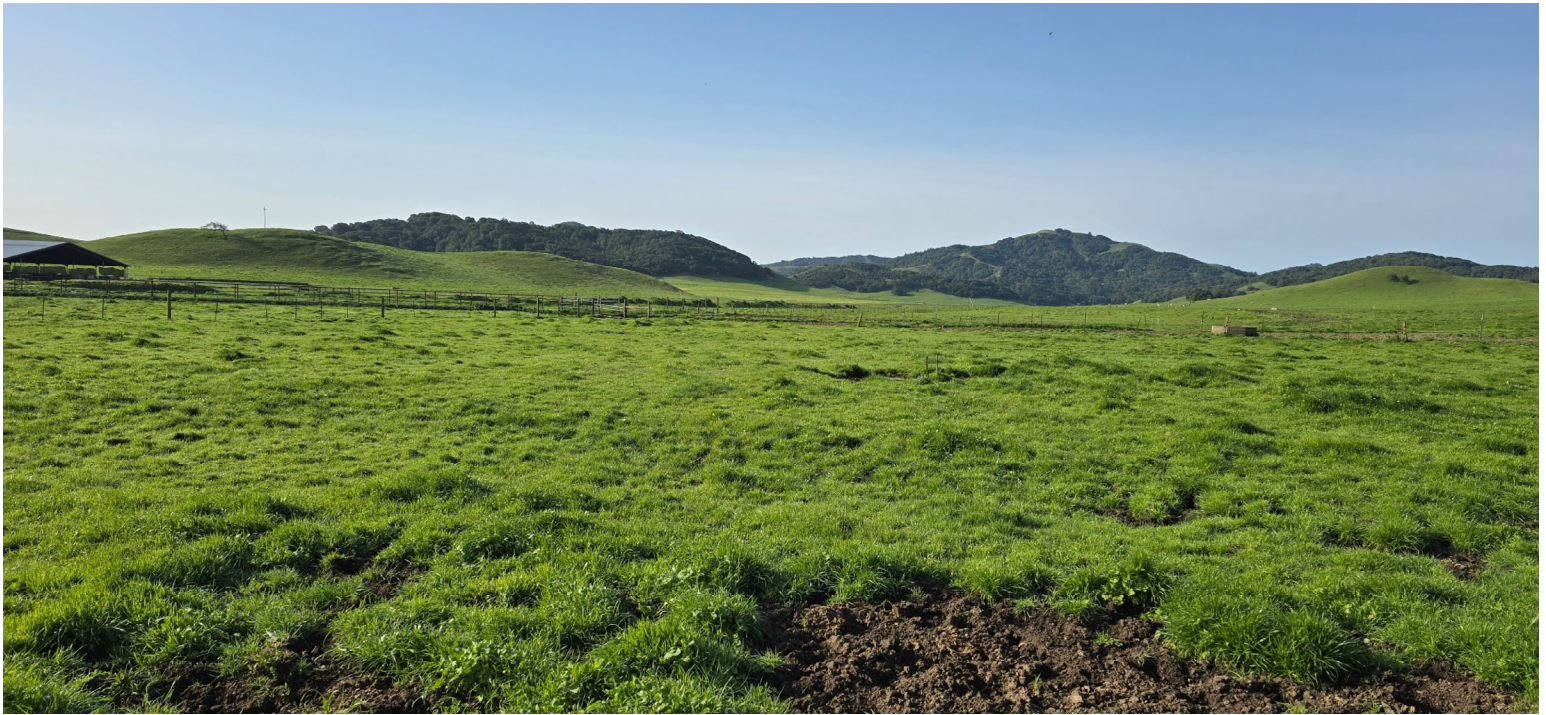
Vegetative buffer

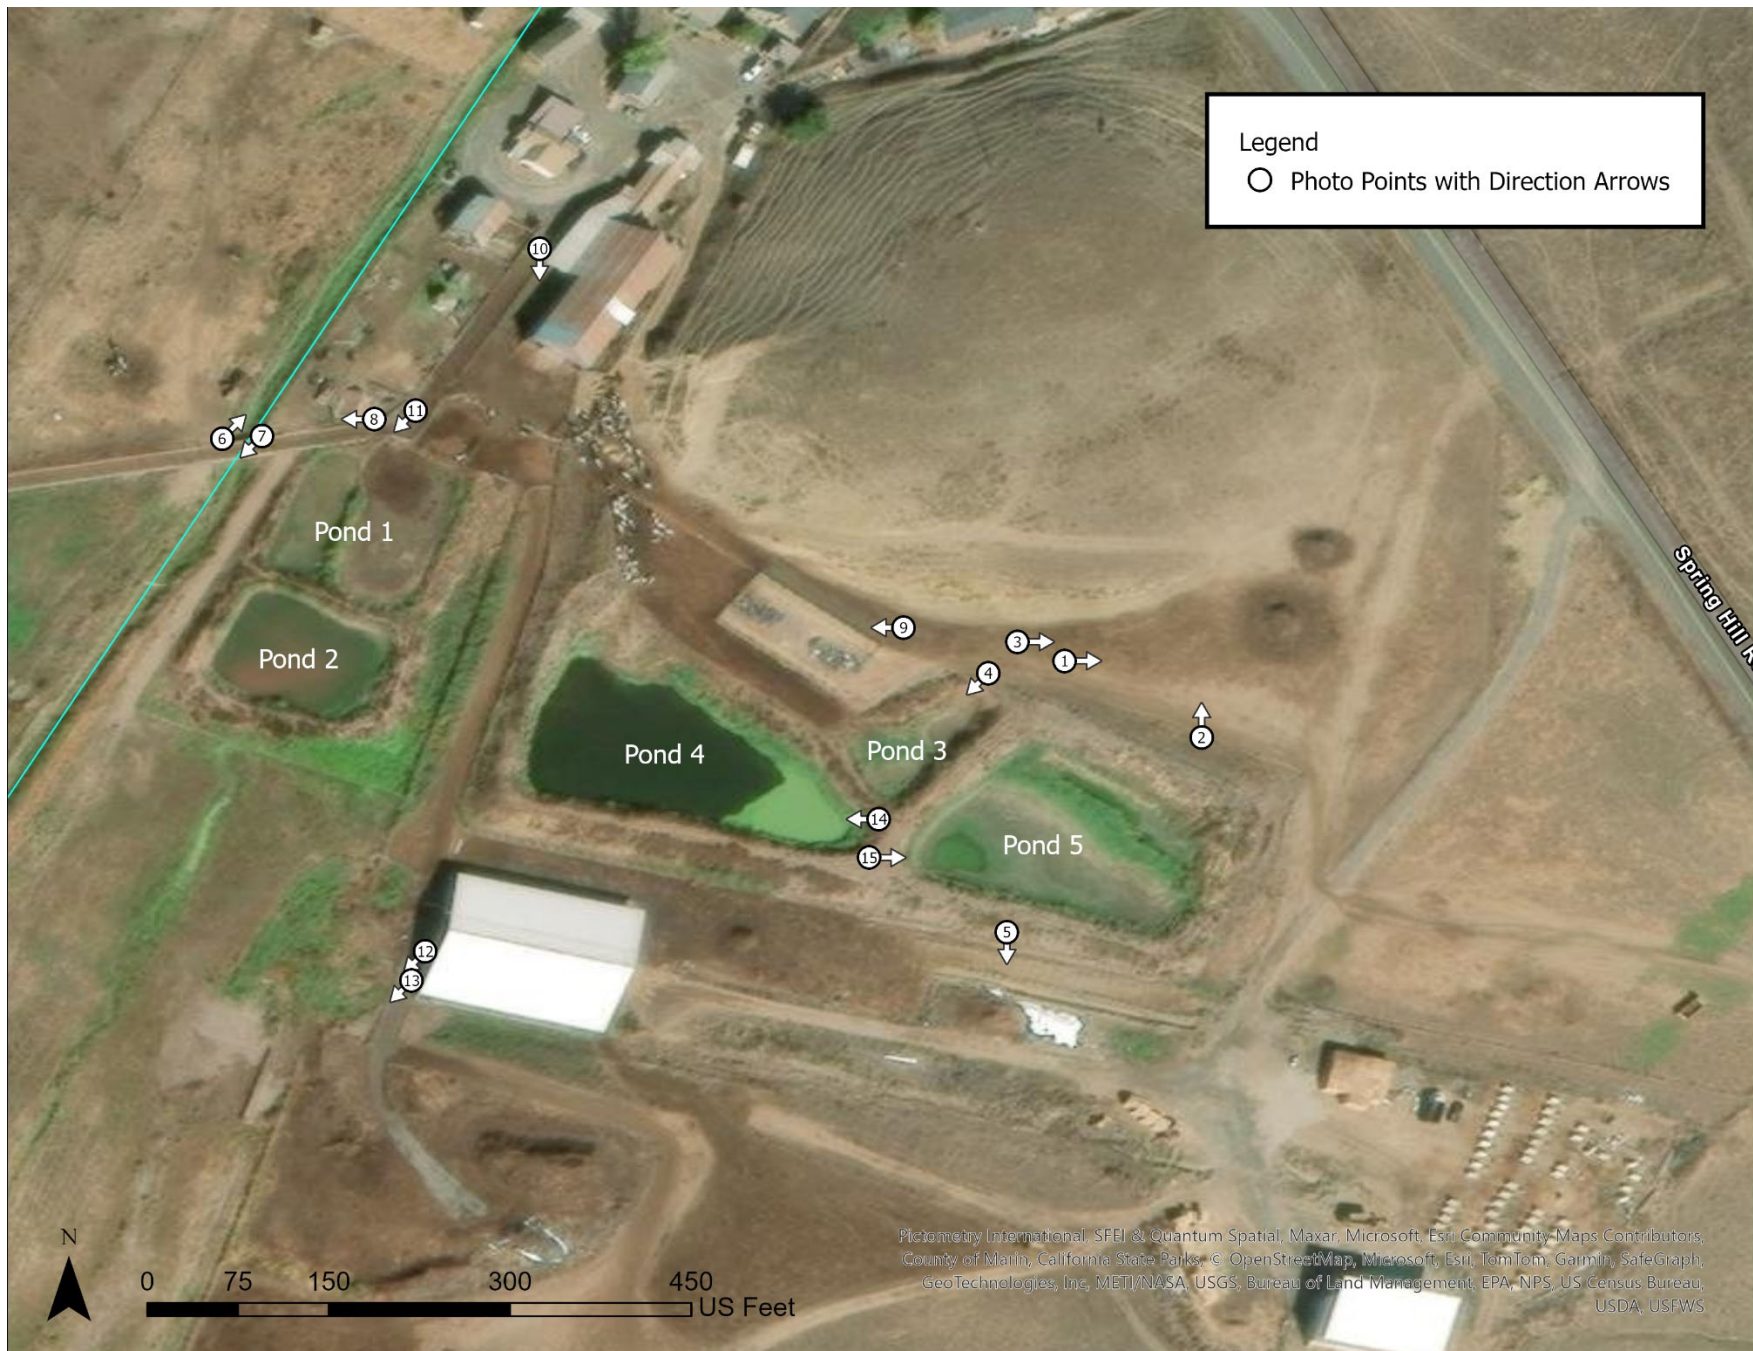
## Facility Map

Photo points are referenced in the above inspection report and/or are included in this section to document the facility's conditions at the time of the inspection. The general location of each photo is marked on the Facility Map.

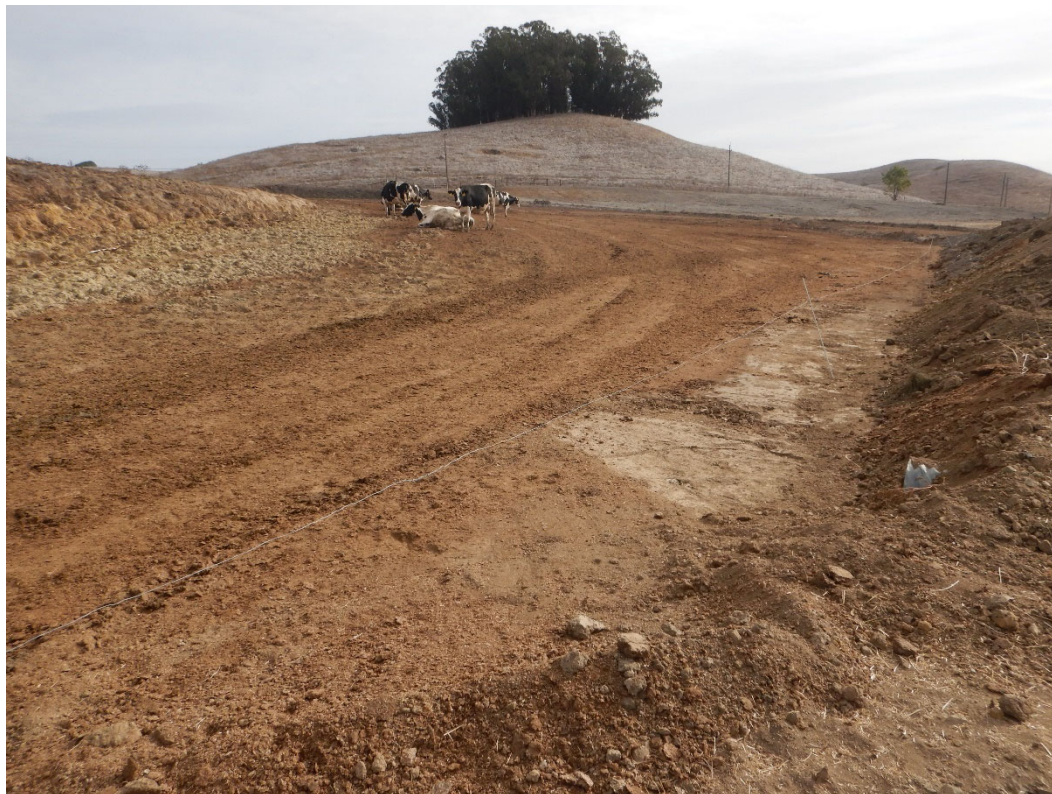
Photo 1: Bermed animal area on the northern hill. Area graded to drain to Pond 3 of the waste pond system. Diversion bar and conveyance pipeline on right.

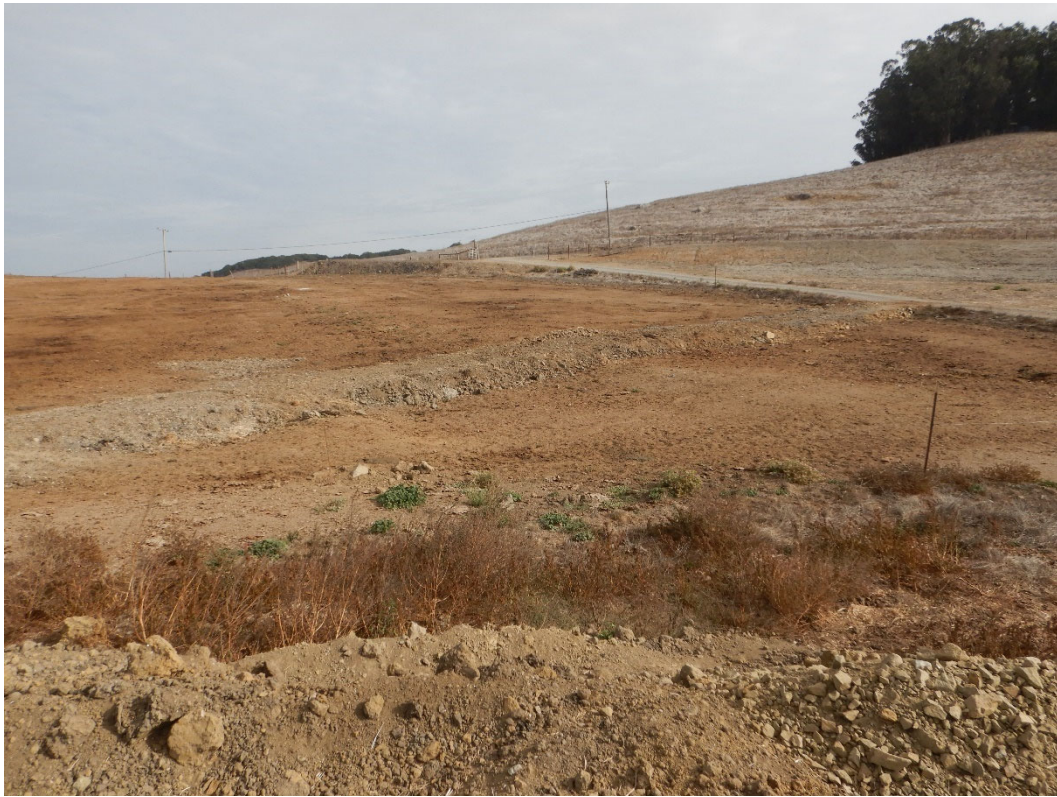
Photo 2: Diversion berms surrounding the animal area to prevent run-on from entering the animal area, and direct runoff within the animal area to the waste pond system.

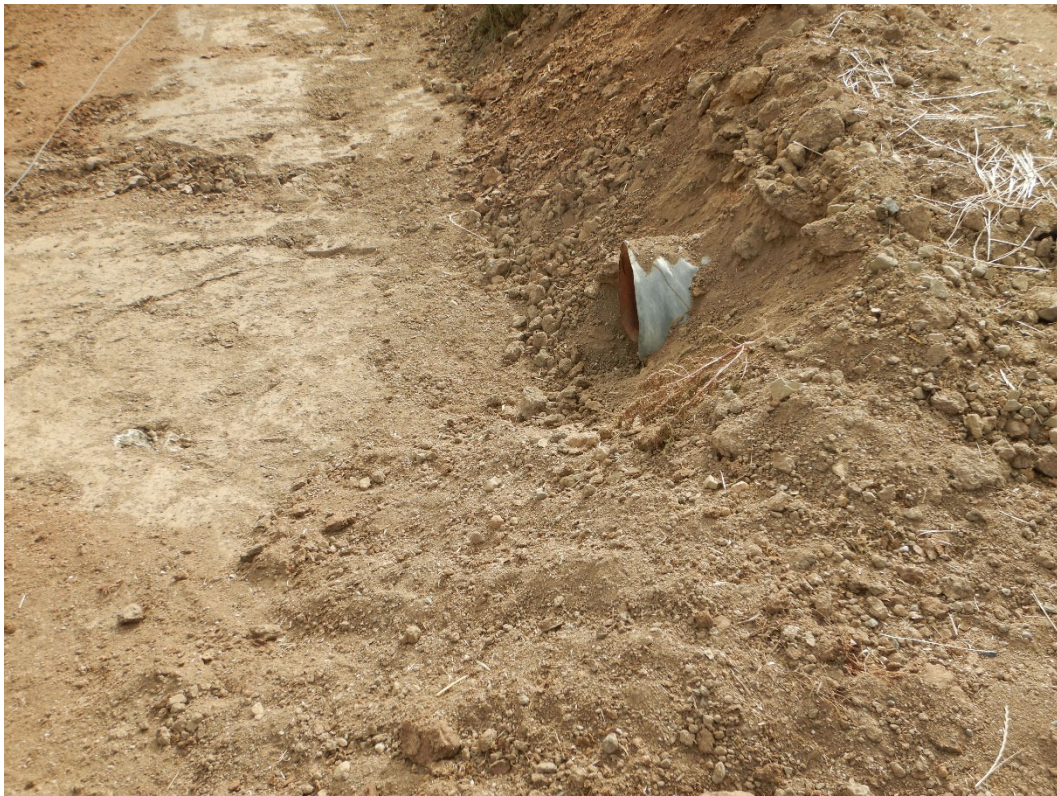
Facility Name: <u>Travis Moreda Dairy</u>	Physical Address: <u>3243 Spring Hill Road, Petaluma, CA</u>
Operator Name: <u>Travis Moreda</u>	Phone #: _____ email: _____
Owner Name (if different): _____	Phone #: _____ email: _____
Type of animals: <u>Dairy Cows</u> # of Animals (specify milking, dry, heifers, calves, mature and young stock) _____	
_____ 295 Dairy Holsteins, per operator/owner account. See 2024 Annual Report.	
Other onsite operations (food processing, compost, animal slaughter, etc.) _____	
General WDR Tier: Tier 1 (no waste retention ponds) _____ Tier 2 (uses waste retention ponds) <u>X</u> Tier 3 (designated higher risk) _____	
Where and how are animals held, housed, and/or confined: Animals are kept in a barn, a bermed animal area (see Photos 1 and 2), and are alternated out on pasture. The bermed animal area has an inset pipe to convey runoff from the area into Pond 3 (see Photos 3 and 4).

Photo 3: Southern diversion berm and conveyance pipeline inlet.

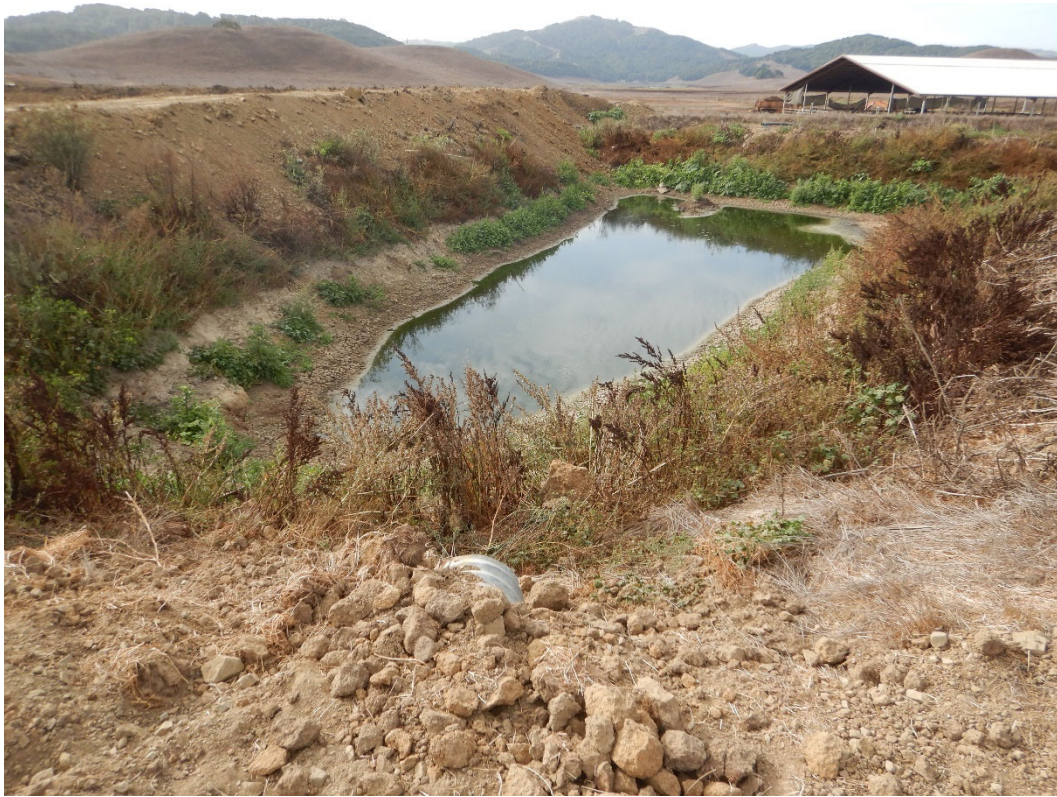
<b>Comments:</b> Operator maintains records of berm and pond integrity and capacity inspections. Pond 1 can be seen in the background of Photo 11, Pond 3 is in Photo 4, Pond 4 and 5 are in Photos 14 and 15 respectively.

Photo 4: Conveyance pipe outlet into Pond 3.

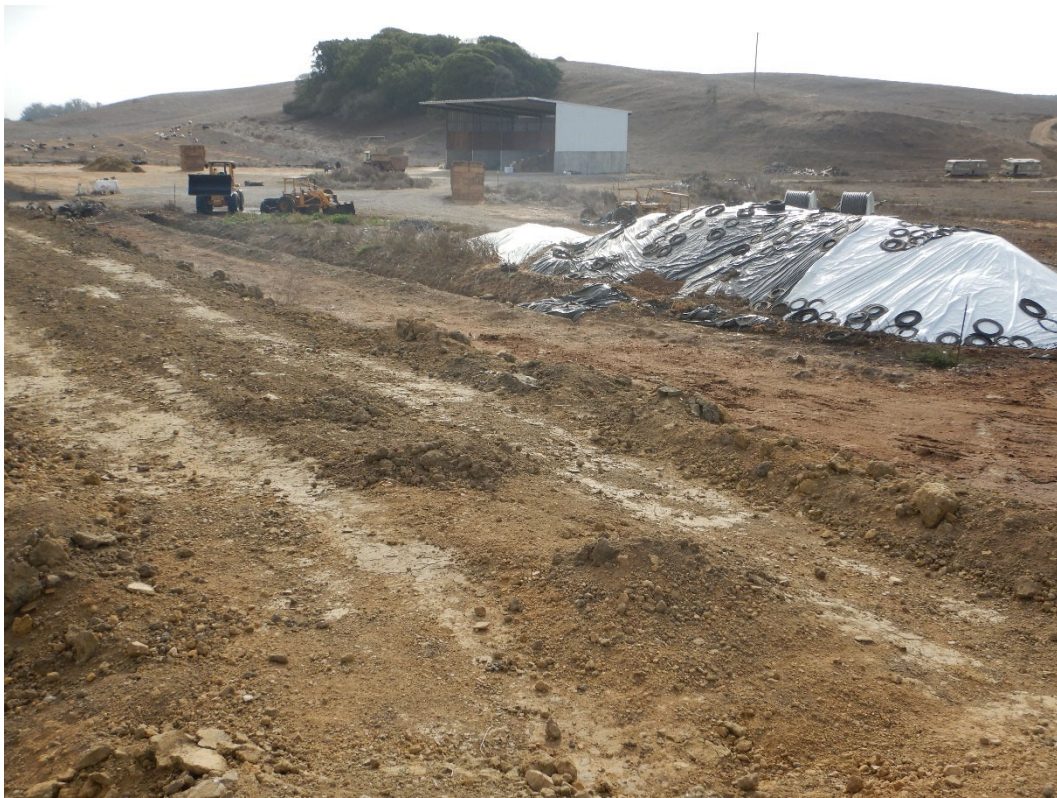
Type of waste containment and/or treatment facilities: The waste containment system is composed of five ponds. The first pond is a combination of two connected smaller ponds, but for the purposes of this report, it will be referred to as a single pond (as shown on the Map). This initial pond (Pond 1) and Pond 2 are responsible for separating soils from liquid waste, after which the liquid waste is pumped into the larger ponds as needed. The smaller Pond 3 collects runoff from a bermed animal area. Solid waste stockpiles are located by the southern barn adjacent to the ponds (see Photo 5).

Photo 5: Waste stockpile area is next to the southern dry materials storage.

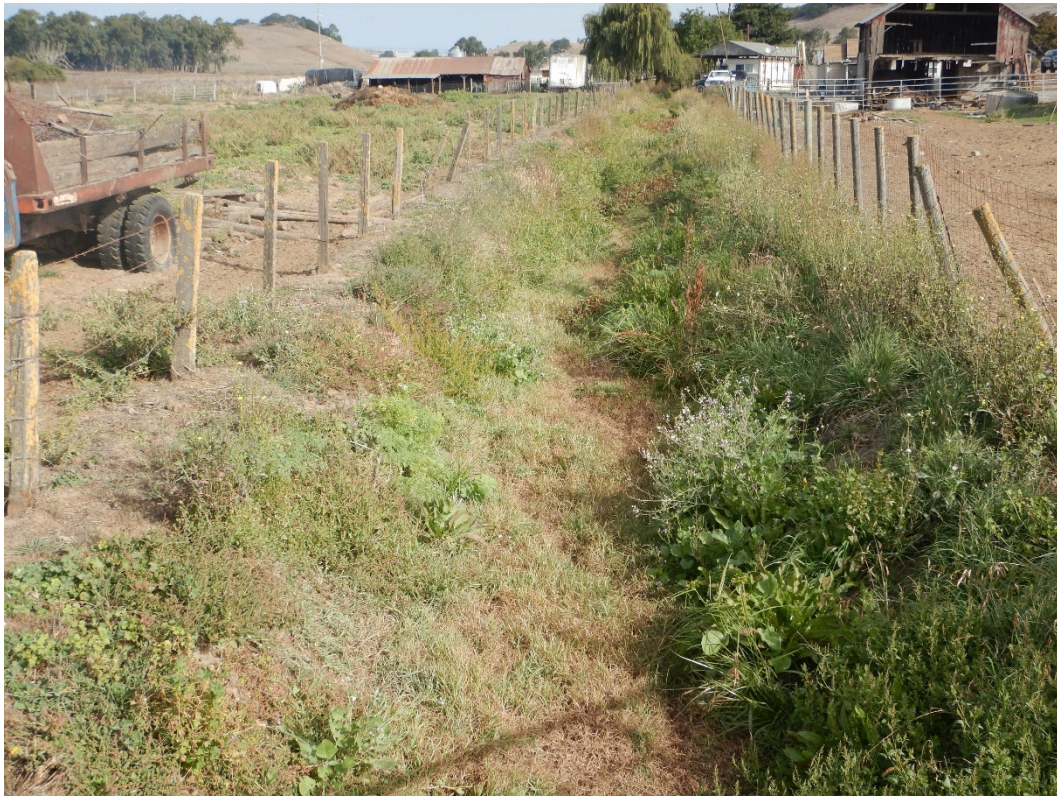
Photo 6: Seasonal drainage, looking upstream from animal pathway.

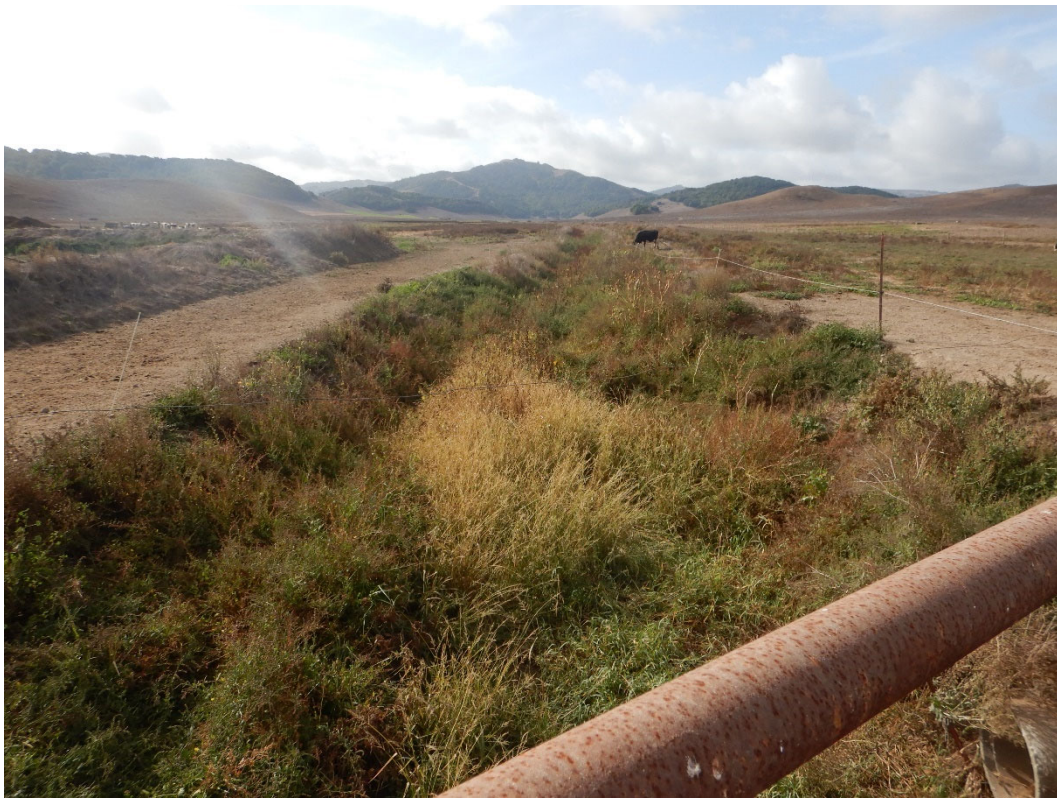
Photo 7: Seasonal drainage, looking downstream from animal pathway.

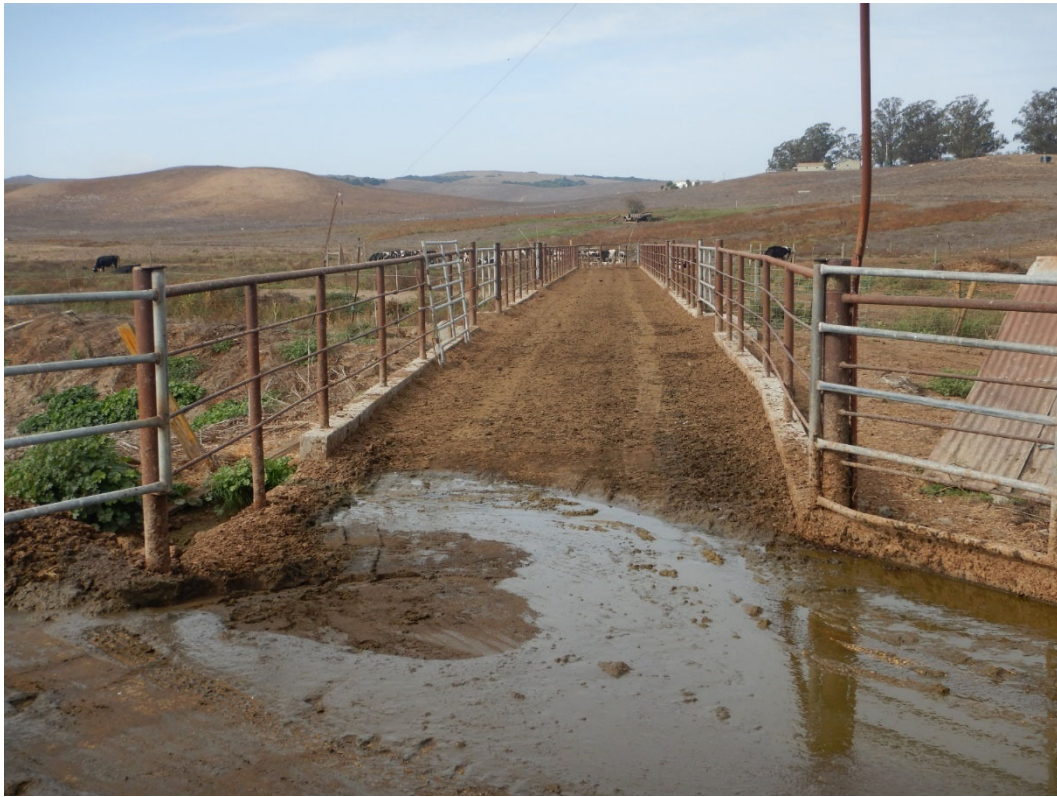
Photo 8: Armored and fenced animal pathway out to pasture.
